## SERVICE BULLETIN REVISION TRANSMITTAL SHEET

TITLE: WINGS - GENERAL - ONE TIME INSPECTION OF TAPERLOK BOLT AT

WING TO FUSELAGE JUNCTION.

This page transmits Revision No.03 of Service Bulletin No.A320-57-1140

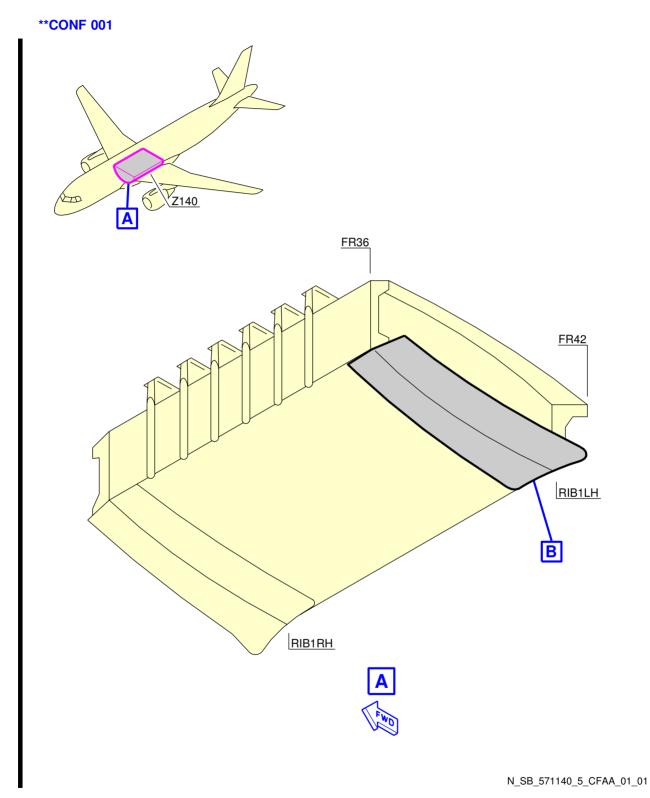
Figure A-FCFAA - Sheet 01 LH Side, Replacement of the Lower Panel Fasteners for the ADDITIONAL WORK

The ADDITIONAL WORK consists in inspecting new fasteners located in the center and outer wing box in the Rib1 area.

- replace the nut by self-locking nut with appropriate washer.
- replace the damaged taperlok with a new taperlok at next nominal diameter with self-locking nut.
